REPORT DOCUMENTATION PAGE		READ INSTRUCTIONS BEFORE COMPLETING FORM
1. REPORT NUMBER	2. GOVT ACCESSION NO. AD-A090 939	3. RECIPIENT'S CATALOG NUMBER
4. TITLE (and Subtitle) Phase I Inspection Report Lake Placid Village Dam Lake Champlain River Basin, Essex County, NY Inventory No. 781		5. TYPE OF REPORT & PERIOD COVERED Phase I Inspection Report National Dam Safety Program

7. AUTHOR(s) John B. Stetson		6. PERFORMING ORG. REPORT NUMBER
9. PERFORMING ORGANIZATION NAME AND ADDRESS Stetson-Dale Engineering Company Bankers Trust Building Utica, NY 13501		8. CONTRACT OR GRANT NUMBER(s) ✓ DACW-51-79-C-0001

ASSESSMENT OF  
GENERAL CONDITIONS

PHASE I INSPECTION REPORT  
NATIONAL DAM SAFETY PROGRAM  
NAME OF DAM - LAKE PLACID VILLAGE DAM ID# - NY 781

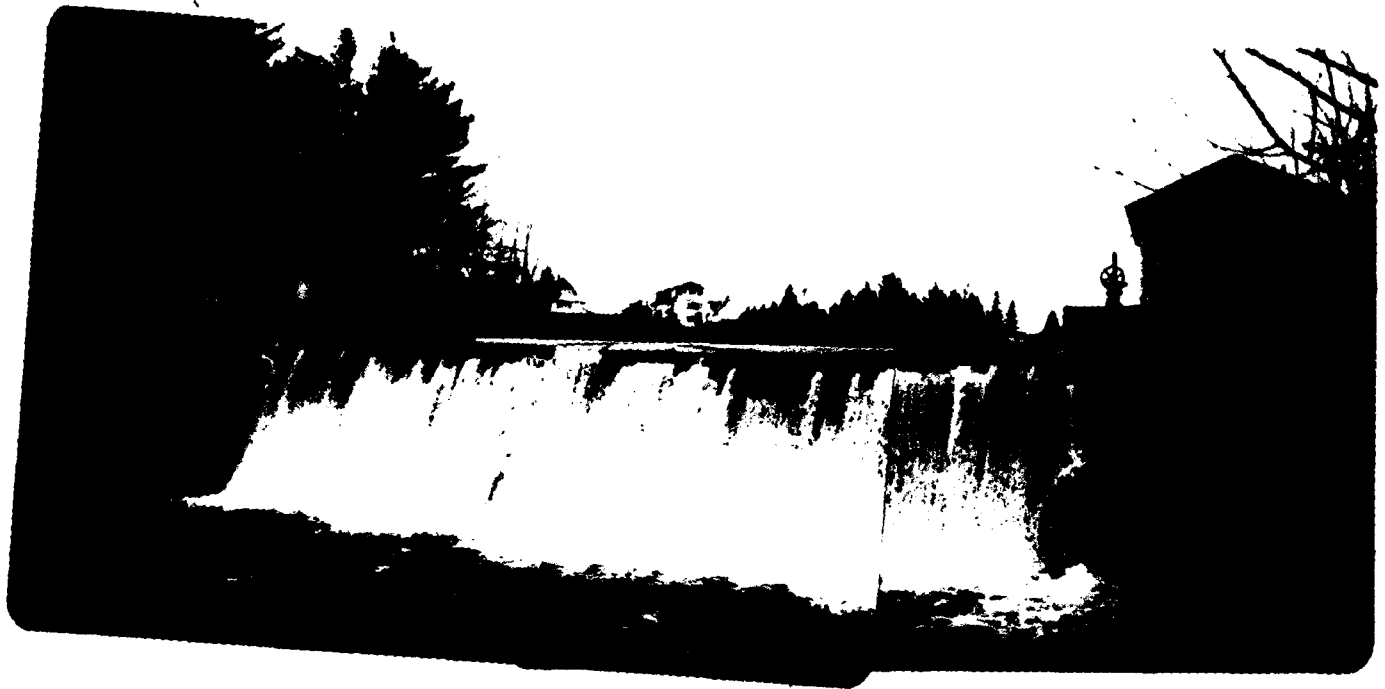
1. Overview of Lake Placid Village Dam NY 781.  
Note deterioration of face of spillway as  
evidenced by irregular pattern of flow.

At the time of the inspection, water was cresting the spillway at a depth of 5 inches. This flow obscured from view the surface of the spillway; however, the irregular pattern of the flow across the crest of the spillway indicates that surface deterioration has taken place on the face of the spillway. The northeast abutment of the spillway is severely deteriorated and partially undercut at the water surface. A similar condition exists, although to a somewhat lesser degree, on the southwest abutment. Visual observation did not disclose physical displacement of the alignment of this structure and despite the severe deterioration of the spillway abutments, the facility shows no visual signs of instability.

1. Repairs to restore the dam's deteriorated concrete on the spillway and both abutments should be undertaken.
2. The channel wall at the toe of the south abutment should be repaired to prevent further deterioration of the bank of the stream and protect the south abutment from erosion.
